## TEST REPORT

No. TR048/45-24

This Test Report describes the accredited Environmental Test carried out on a specimens of Carbon Steel Insulation fasteners (5x part number IS100 and 5x part number IS180) and Stainless-Steel Insulation fasteners (5x part numbers A4IS140 and 5x A4IS180). The procedure was required to assess the resistance of the specimens to a humid atmosphere containing Sulphur Dioxide SO<sub>2</sub>. Product tested 16/10/24 until 31/10/24.

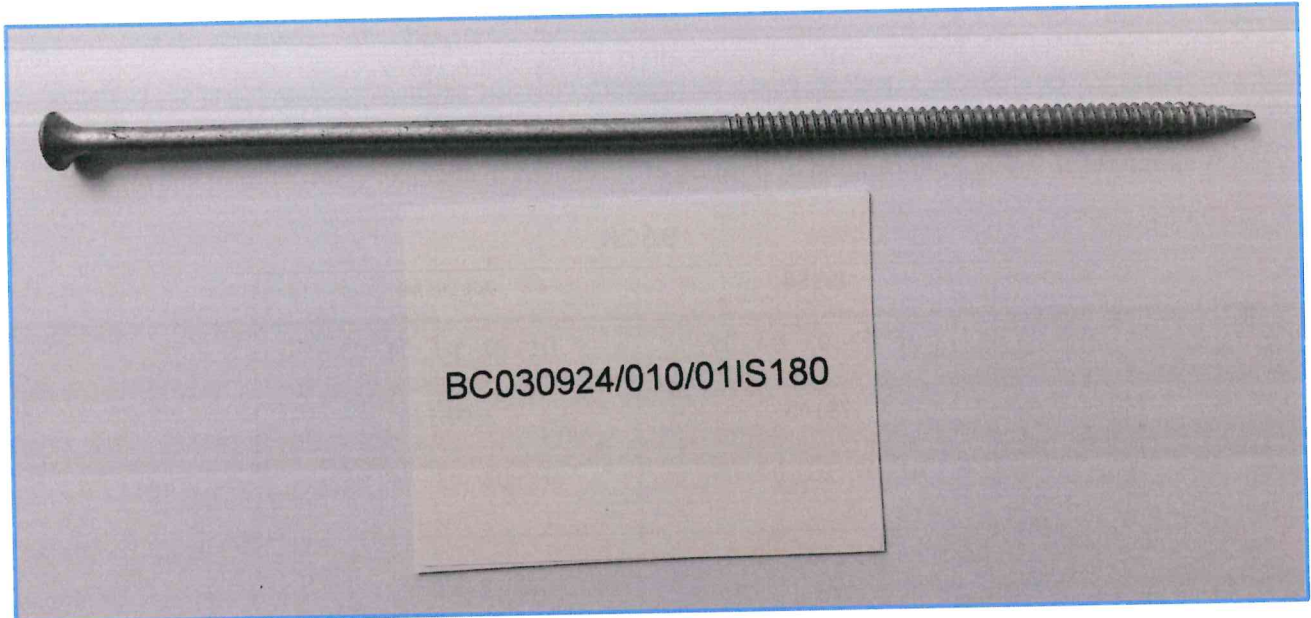
Figure 6: Specimen BC030924/010/01IS180 After Test

All specimens showed varying degrees of tarnish. The pass or fail decisions for each case will at the discretion of the customer on receipt of returned specimens.
