## TEST REPORT

No. TR048/45-24

This Test Report describes the accredited Environmental Test carried out on a specimens of Carbon Steel Insulation fasteners (5x part number IS100 and 5x part number IS180) and Stainless-Steel Insulation fasteners (5x part numbers A4IS140 and 5x A4IS180). The procedure was required to assess the resistance of the specimens to a humid atmosphere containing Sulphur Dioxide SO<sub>2</sub>. Product tested 16/10/24 until 31/10/24.

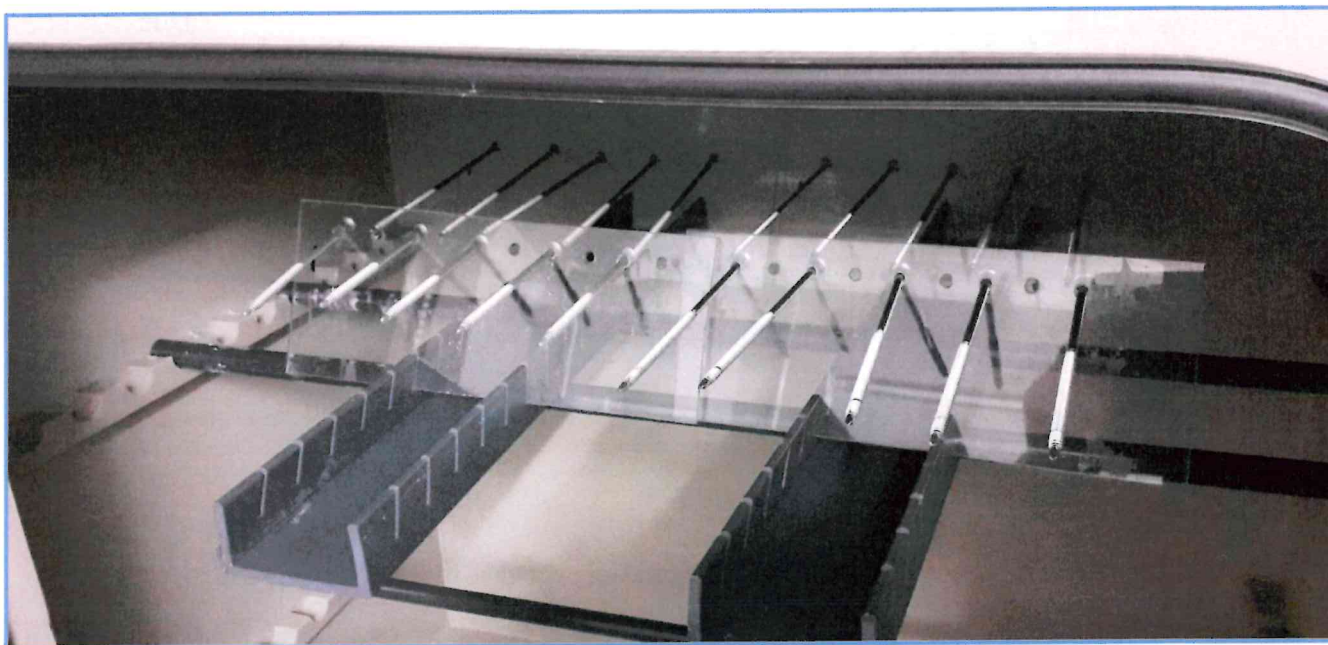
The 20 specimens were prepared for test by cleaning/de-greasing using isopropyl alcohol (IPA). These were then mounted on jigs as suggested by the customer and located inside the chamber with consideration for positioning between specimens and proximity to chamber walls. Fig 5.

Figure 5: View of Specimens Positioned Inside the Kesternich Chamber. Substitute Specimens not in-Situ for Clarity
